PlexiArm X4 & X8 – Triple-Click Snap Fit Fatigue Test

Production Sample Validation

PlexiArm Validation – Introduction: Snap Fit Fatigue Test

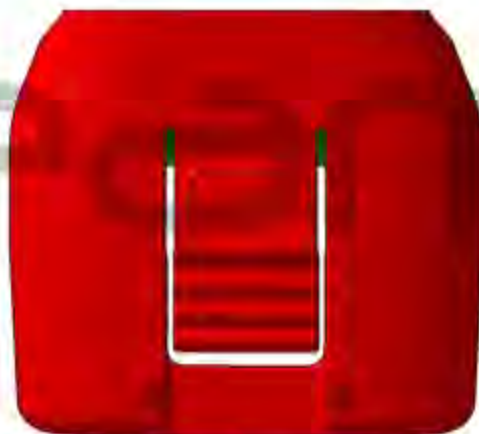
Figure 1: Crack Inspection Area (Green: Allowed Area - Red: Failed Area)

1. Crack initiation around the spring loaded locking feature. **Crack initiation and discoloration is allowed in the green area shown in Figure 1 below*
2. Excessive play between PlexiArm and PlexiDrone's arm stub
3. Ability to insert into the incorrect arm slot

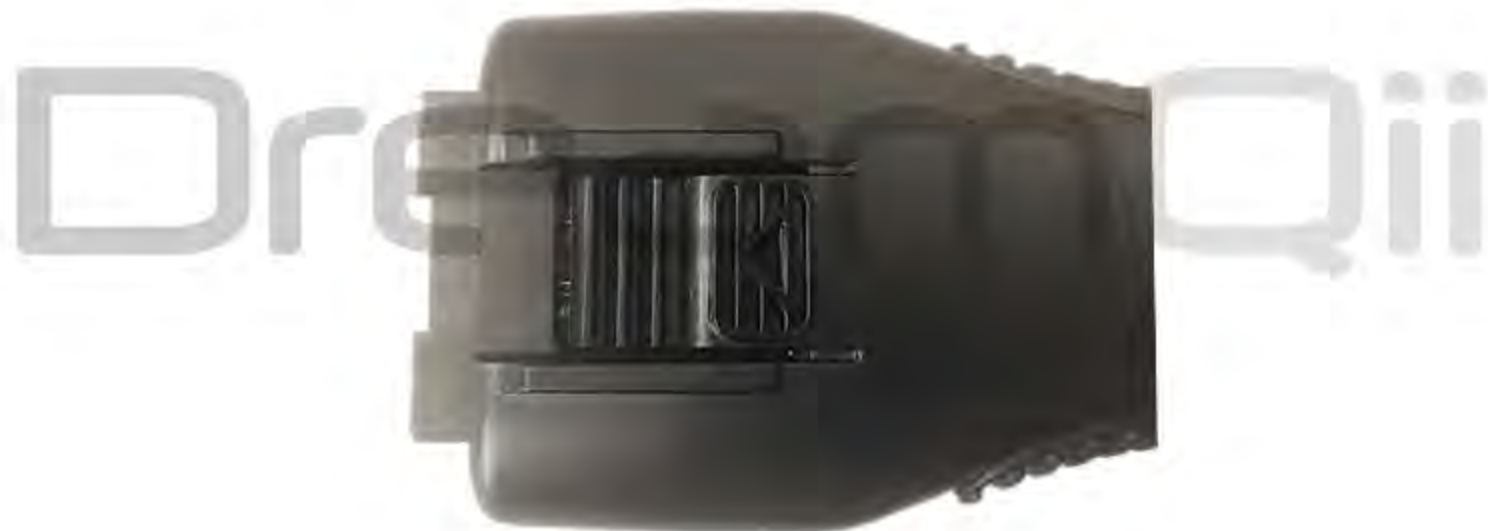
PlexiArm Validation – *Sample 1: Pre-Test Inspection*

- Pre-test inspection completed
- Sample 1: PlexiArm X4 Black – LR
- Newly assembled sample with zero (0) actuation cycles
- No defects found around spring loaded locking feature

Pass

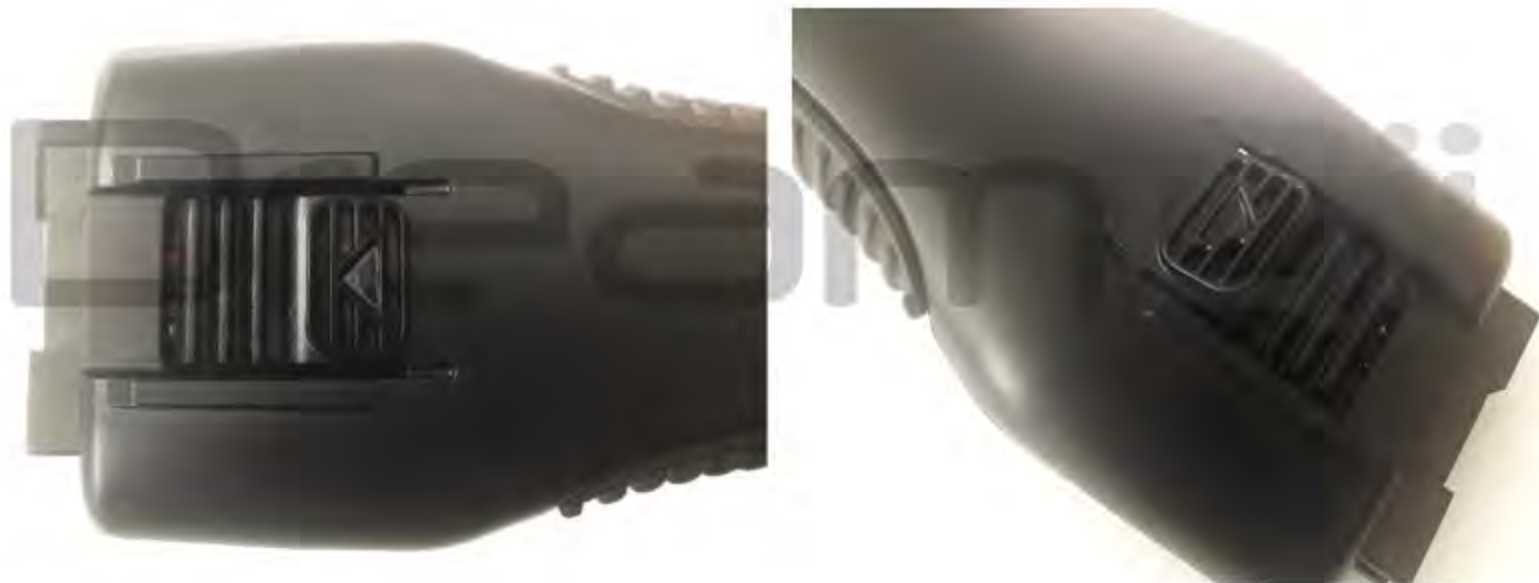
PlexiArm Validation – Sample 1: 100 Cycles Completed

- 100 cycles completed
- No defects found around sample 1 spring loaded locking feature

Pass

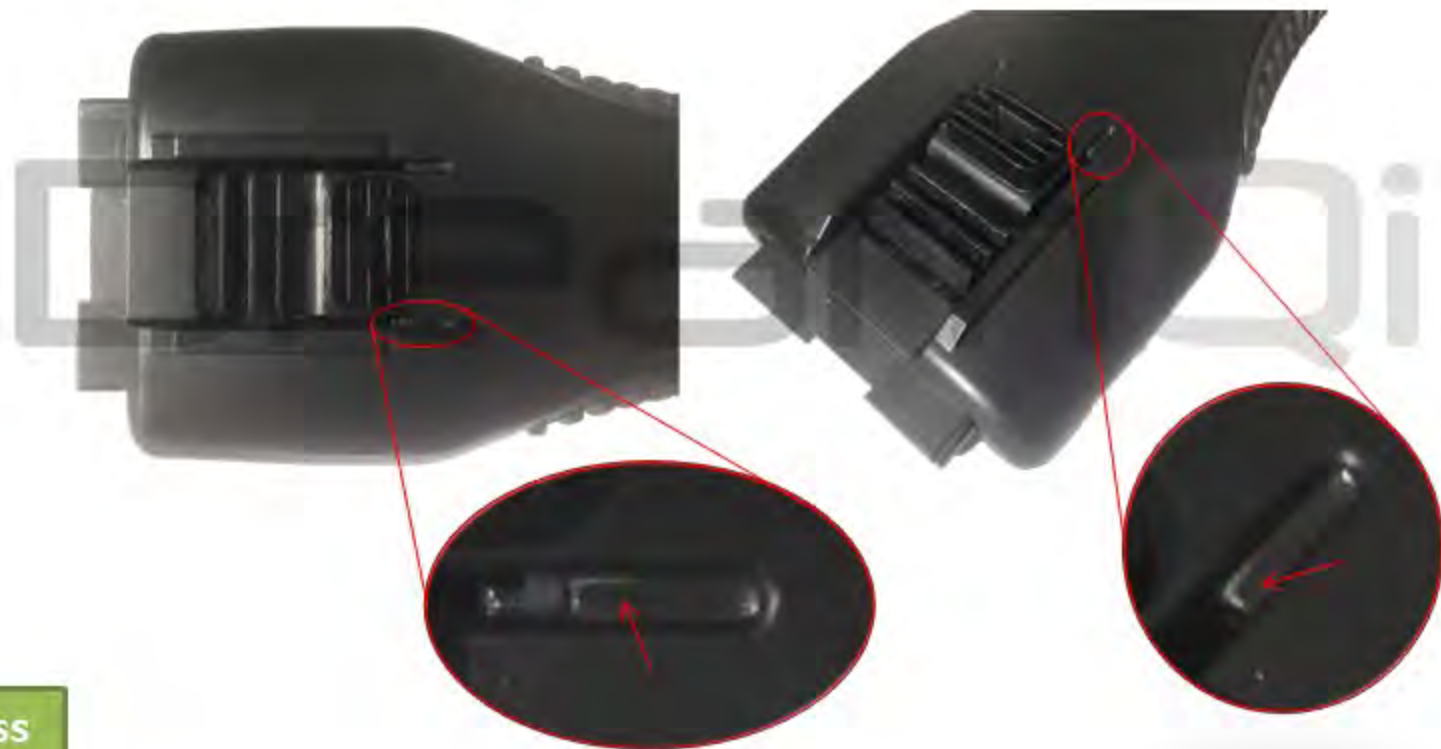
PlexiArm Validation – Sample 1: 200 Cycles Completed

- 200 cycles completed
- No defects found around sample 1 spring loaded locking feature
- Minor discoloration found on allowable area

Pass

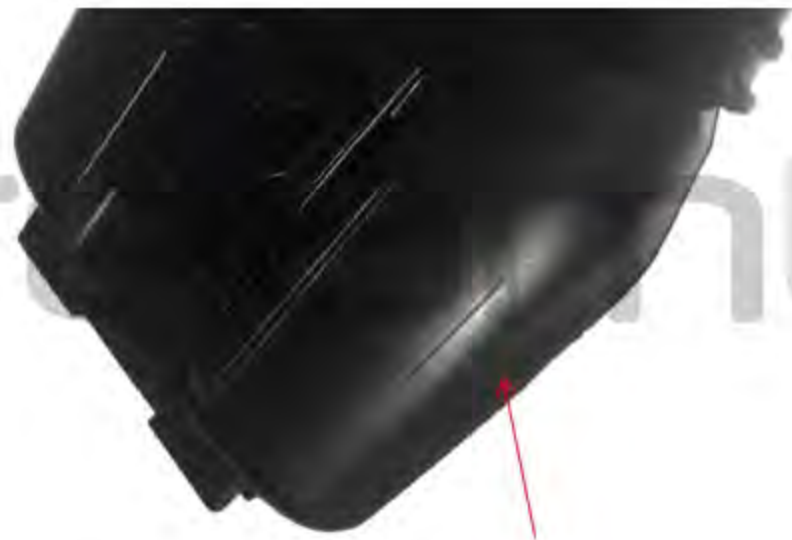
PlexiArm Validation – Sample 1: 200 Cycles Completed

- Matted surface shown minimal aesthetic wear

Pass

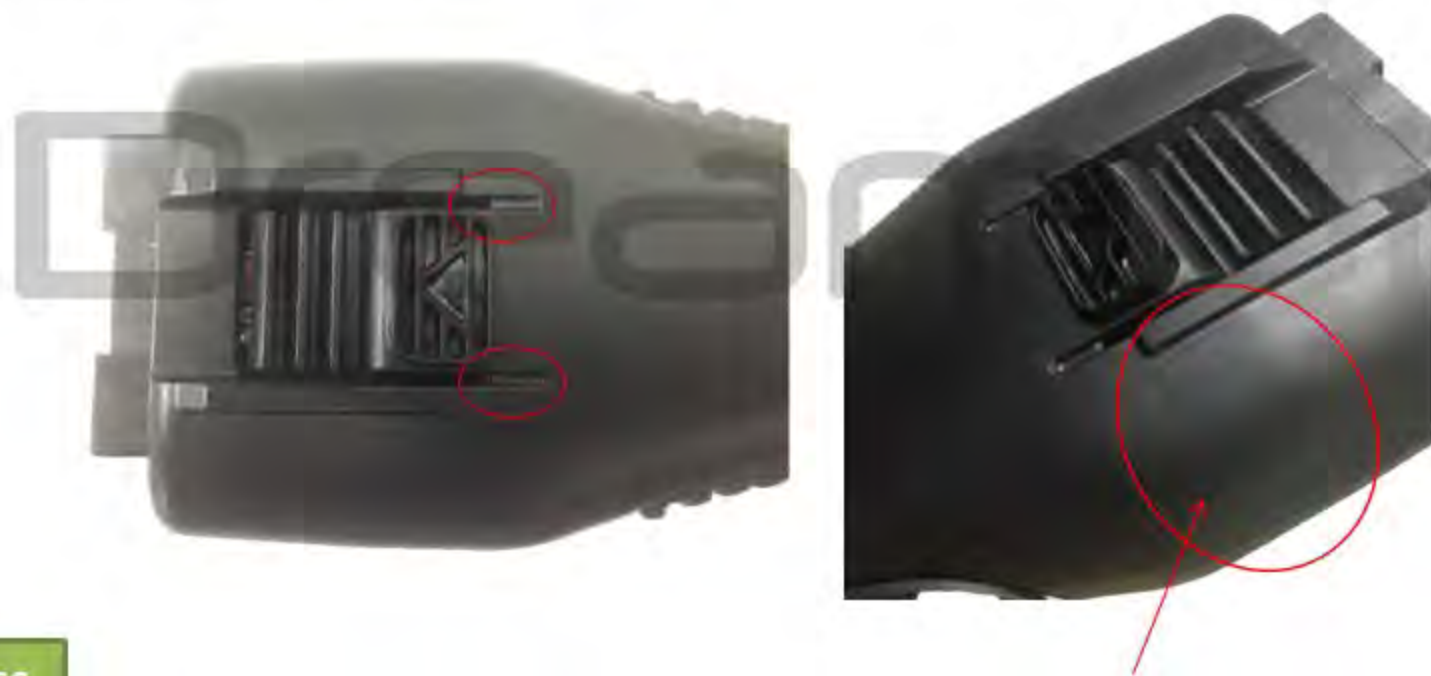
PlexiArm Validation – Sample 1: 300 Cycles Completed

- 300 cycles completed
- No defects found around sample 1 spring loaded locking feature
- Minor discoloration found on allowable area (has not propagated after an additional 100 cycles)
- Matted texture has minimal aesthetic wear

Pass

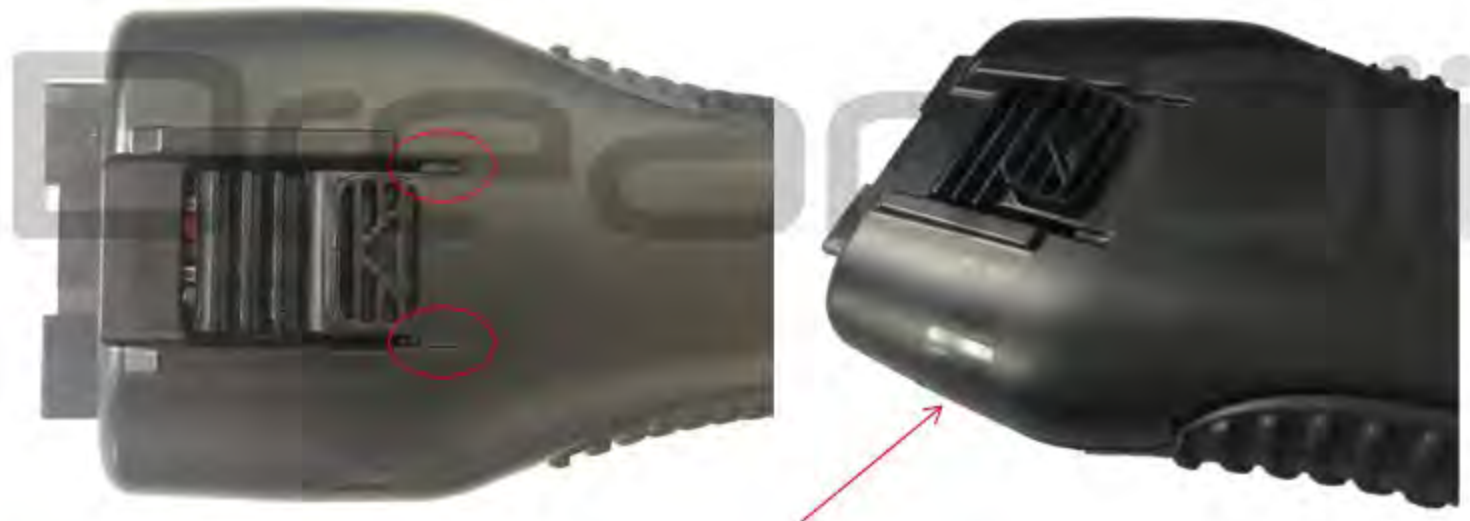
PlexiArm Validation – Sample 1: 400 Cycles Completed

- 400 cycles completed
- No defects found around sample 1 spring loaded locking feature
- Minor discoloration found on allowable area (has slowly propagated after the last stage)
- Matted texture wear has increased

Pass

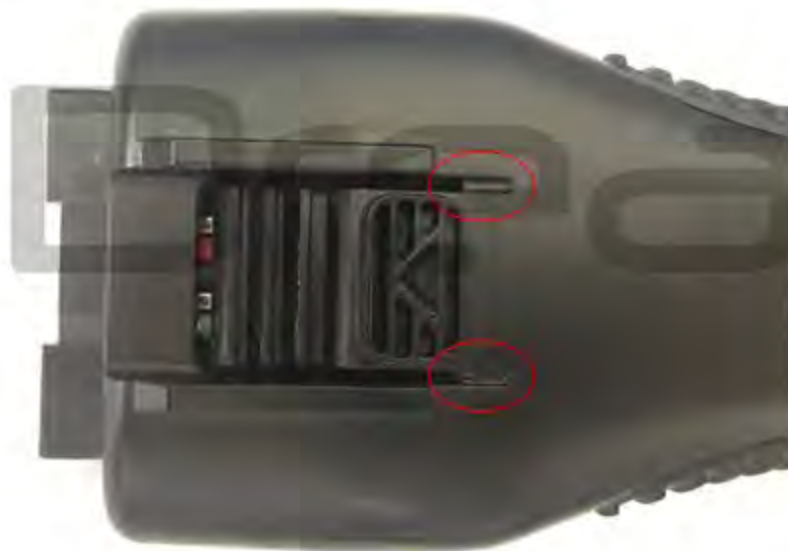
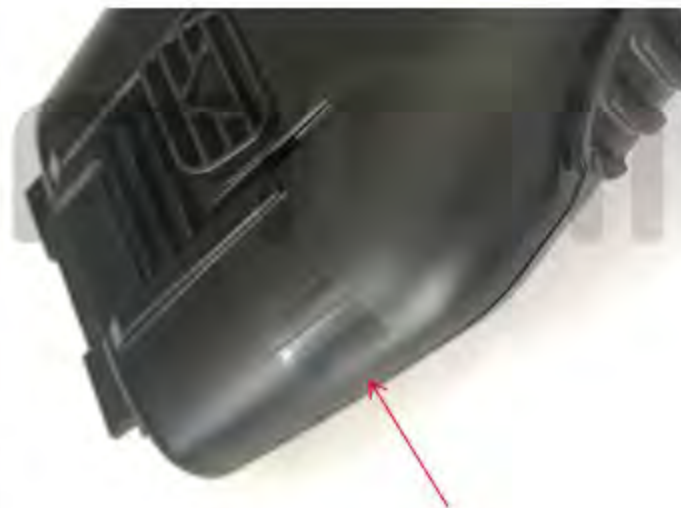
PlexiArm Validation – Sample 1: 500 Cycles Completed

- 500 cycles completed
- No defects found around sample 1 spring loaded locking feature
- Minor discoloration found on allowable area (appears virtually the same as previous stage)
- Matted texture wear has increased

Pass

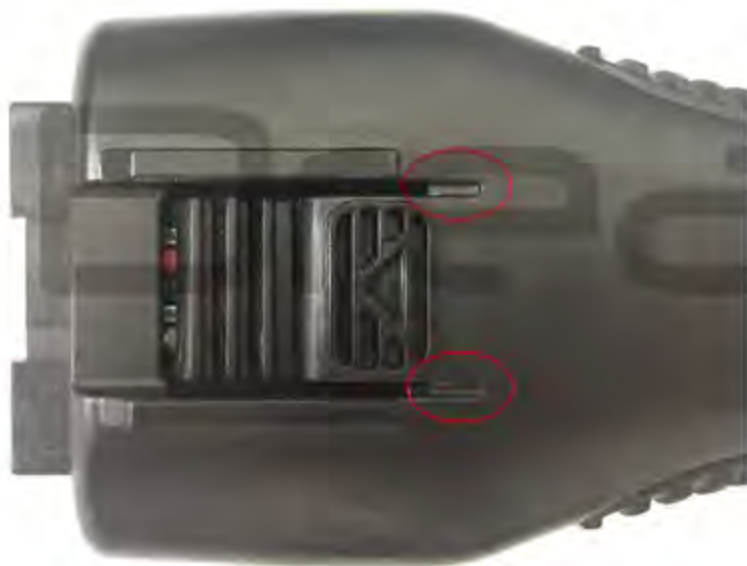
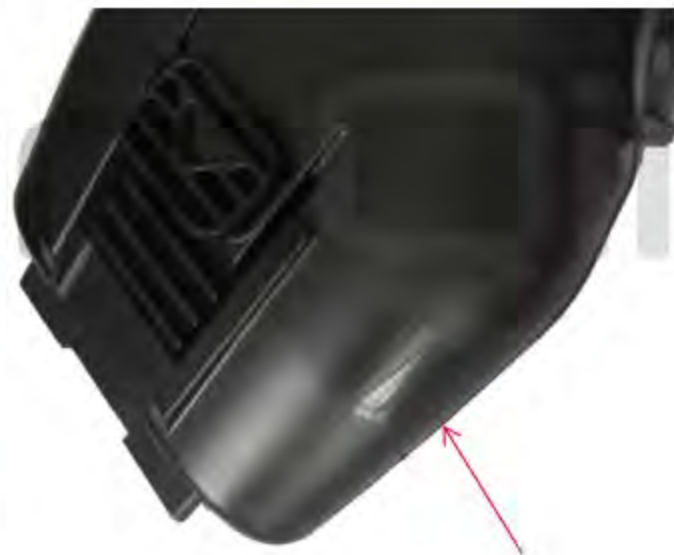
PlexiArm Validation – Sample 1: 600 Cycles Completed

- 600 cycles completed
- No defects found around sample 1 spring loaded locking feature
- Minor discoloration found on allowable area (has slowly propagated after the last stage)
- Matted texture wear has increased

Pass
